METALLURGICAL COMPARISON OF 5 INCH/54 NAVAL TUBES  
FIRED WITH NACO AND PYRO PROPELLANT

Richard Griffin

Watervliet Arsenal  
Watervliet, New York

April 1975

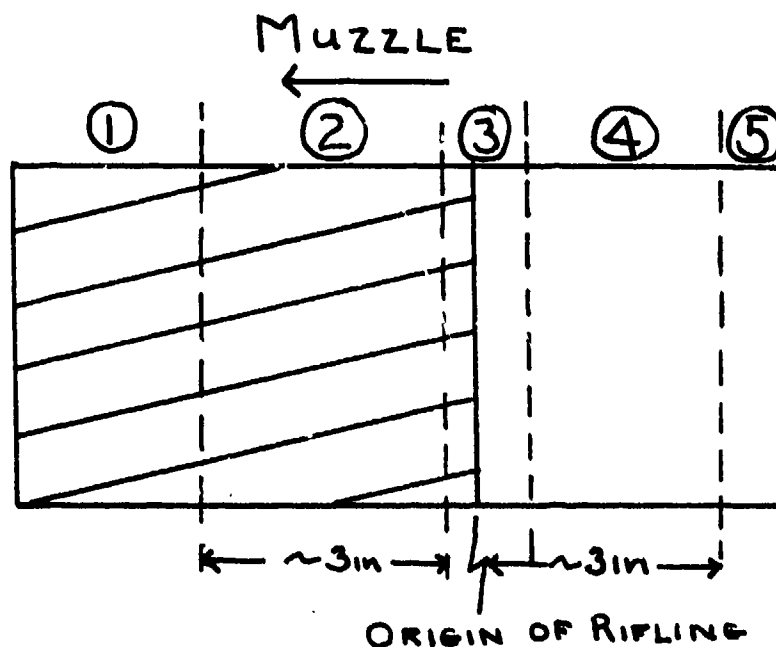
Figure 1. Schematic drawing of the tube and how it was sectioned.

The tubes were sectioned so they could be examined in the origin of rifling region, the portion known to exhibit the maximum erosion and structural damage<sup>1</sup>. Figure 1 is a schematic drawing representing the areas from which the specimens were cut. The area examined in this study was the region covering approximately  $\pm 3$  inches about the origin of rifling. Samples were polished, etched, and examined optically. Hardness readings were made with a Leitz microhardness tester using a 10 gram load.

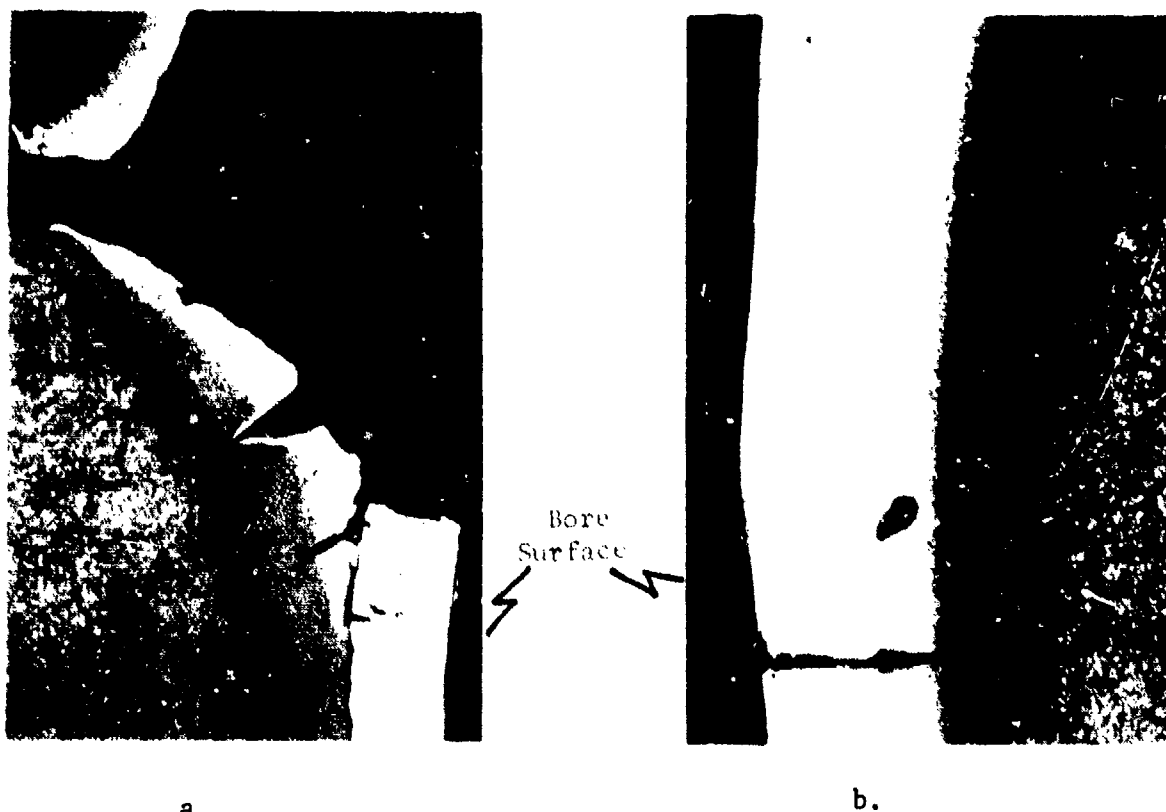
Microscopically there are also differences that show up between the two propellants. When the chrome plating stays intact as it generally did in the Naco fired tube, little structural change occurs in the base metal. Figure 3a shows a typical micrograph for a sample sectioned from area 1, 2, and 3 on tube 52, where the chrome was removed. The sample shown in figure 3b for tube 7 was representative of the entire surface examined. Where the total thicknesses of transformed metal can be compared, it is readily apparent the tube fired with the Pyro propellant shows more heat-affected material. The thickest region measured with the Naco propellant was approximately 0.127mm while for the Pyro, it was 0.26mm, or better than twice as thick. In comparing the thickness of the various layers within the heat affected zone, it appears that the tube fired with Naco has an inner white layer that is thicker than the layer produced in the tube fired with Pyro. There were only a few areas available for comparison, so the above statement is very qualitative.

Figure 3. 200X Micrographs showing representative microstructures for the tubes.  
 a. Tube No. 52, about 2 in. ahead of the origin of rifling  
 b. Tube No. 7 chamber section

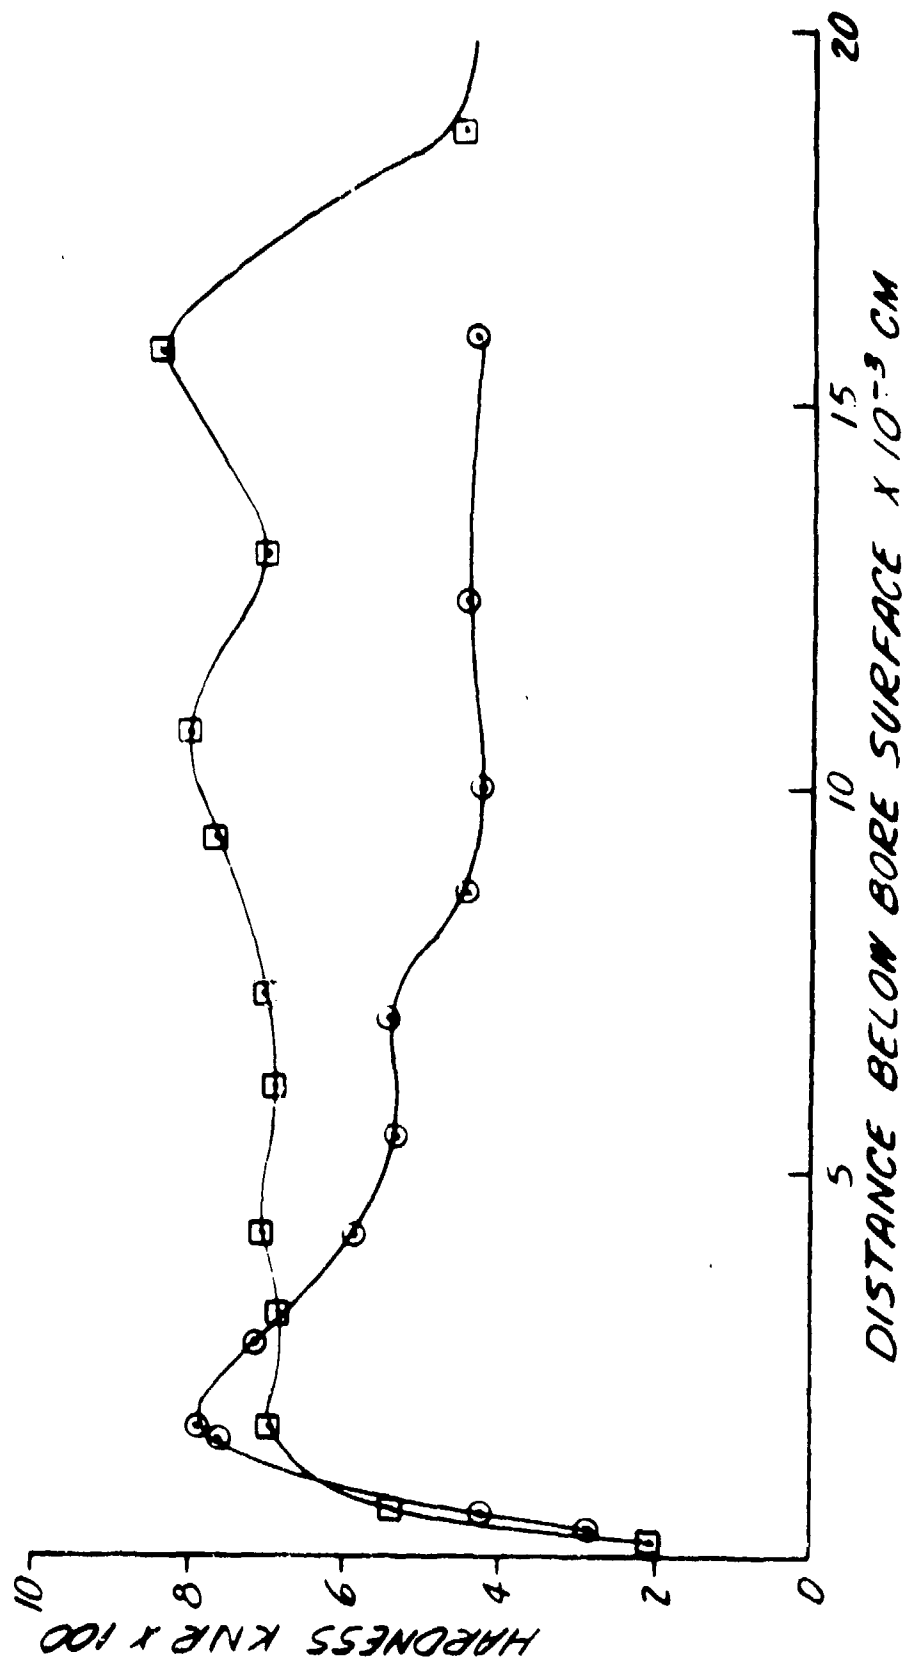
Figure 4 plots the hardnesses at various depths below the bore surface for the two tubes and figure 5 shows the location of the hardness readings throughout the heat affected zone. Referring to figure 4, the circles represent the tube fired with Naco. We see a low initial value rapidly rising in the first 0.002cm to 800 KHN and then tailing off to the hardness of the unaffected quenched and tempered martensite. Likewise, the tube fired with Pyro showed a low initial value associated with the inner white layer and a rapid rise to about 700 KHN units where it remained relatively constant from 0.002 to 0.006cm. The hardness increased to 800 KHN units, and finally at about 0.006 or 0.017 cm, it began to decrease to the hardness of the quenched and tempered martensite.

Figure 4. The change in hardness as a function of the distance below the bore surface.

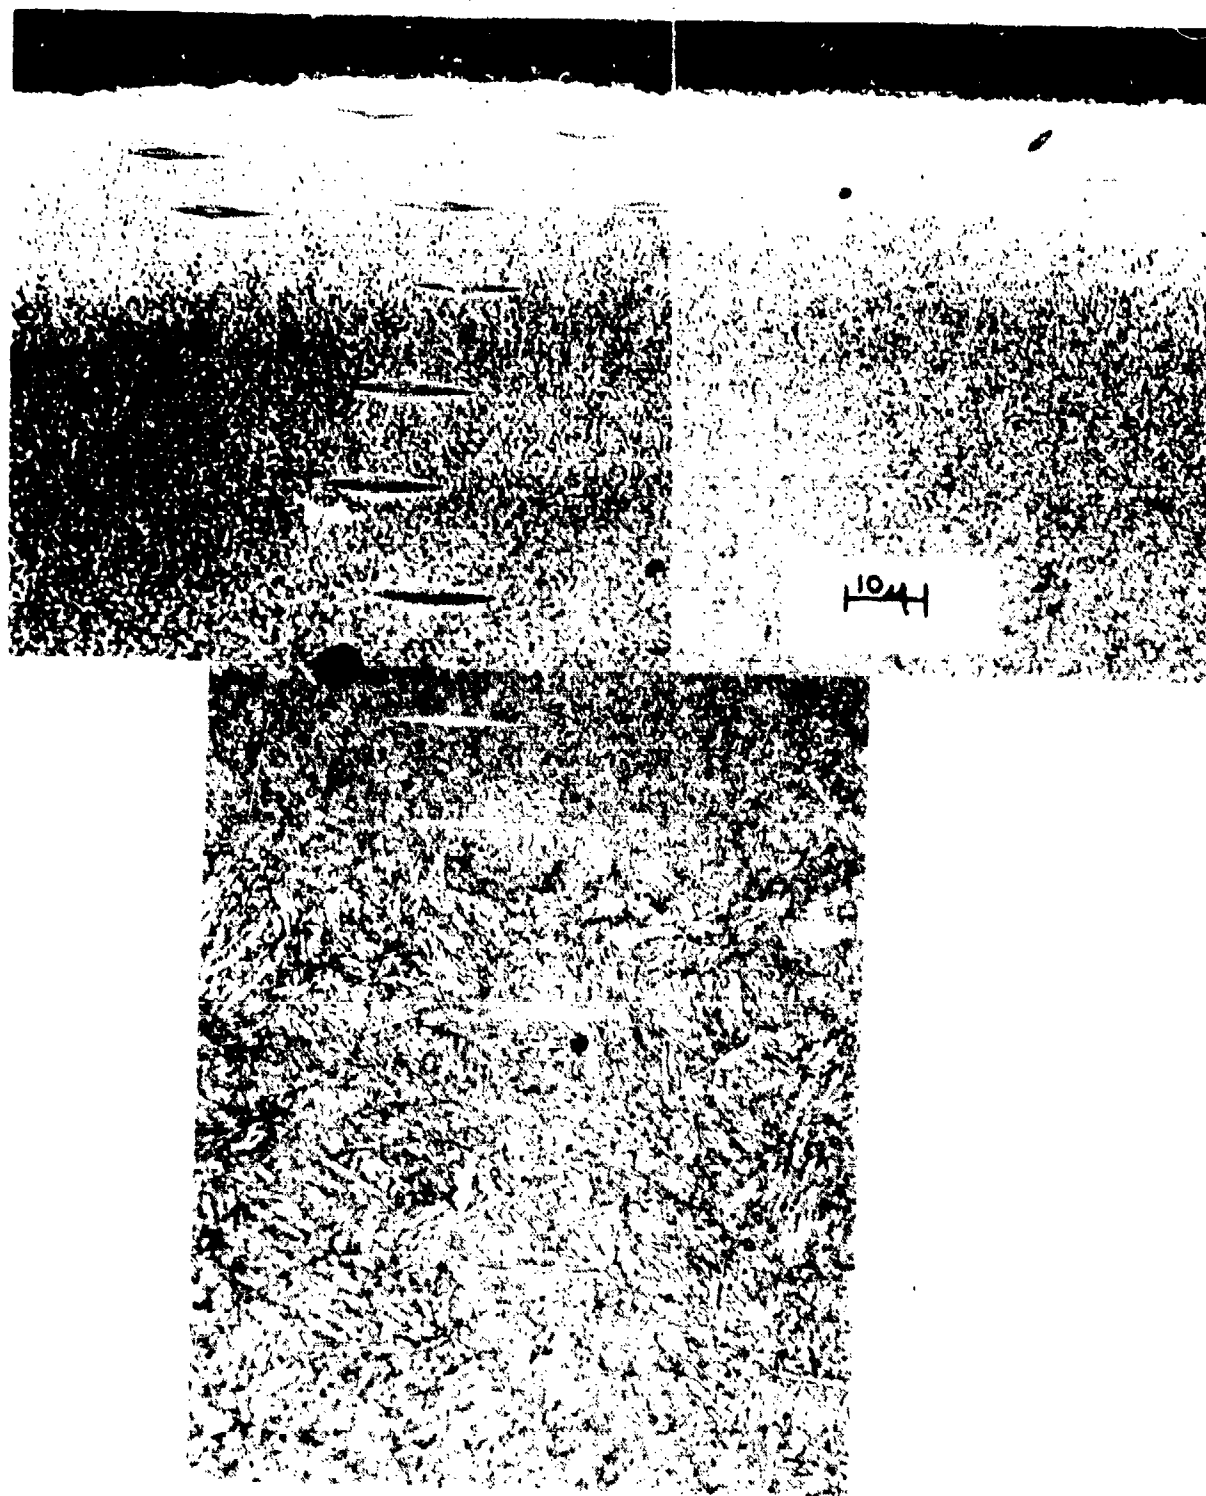
Figure 5a. Tube fired with Pyro, 1500 rounds. Hardness variation across the thermally altered layer. 10g load, KHN indenter, etchant 2% nital.

The larger extent of the heat affected zone of the tube fired with Pyro, shown in figure 5a is immediately apparent when compared with figure 5b. Also, figure 5a shows grain growth near the bore surface as well as a low hardness value near the surface. This was representative of all the areas examined for the tube fired with Pyro. A possible reason for this may be related to the fact that the Pyro propellant produces a peak temperature in the origin of rifling region of about 1200C, compared to about 870C for the Naco Propellant<sup>2</sup>.

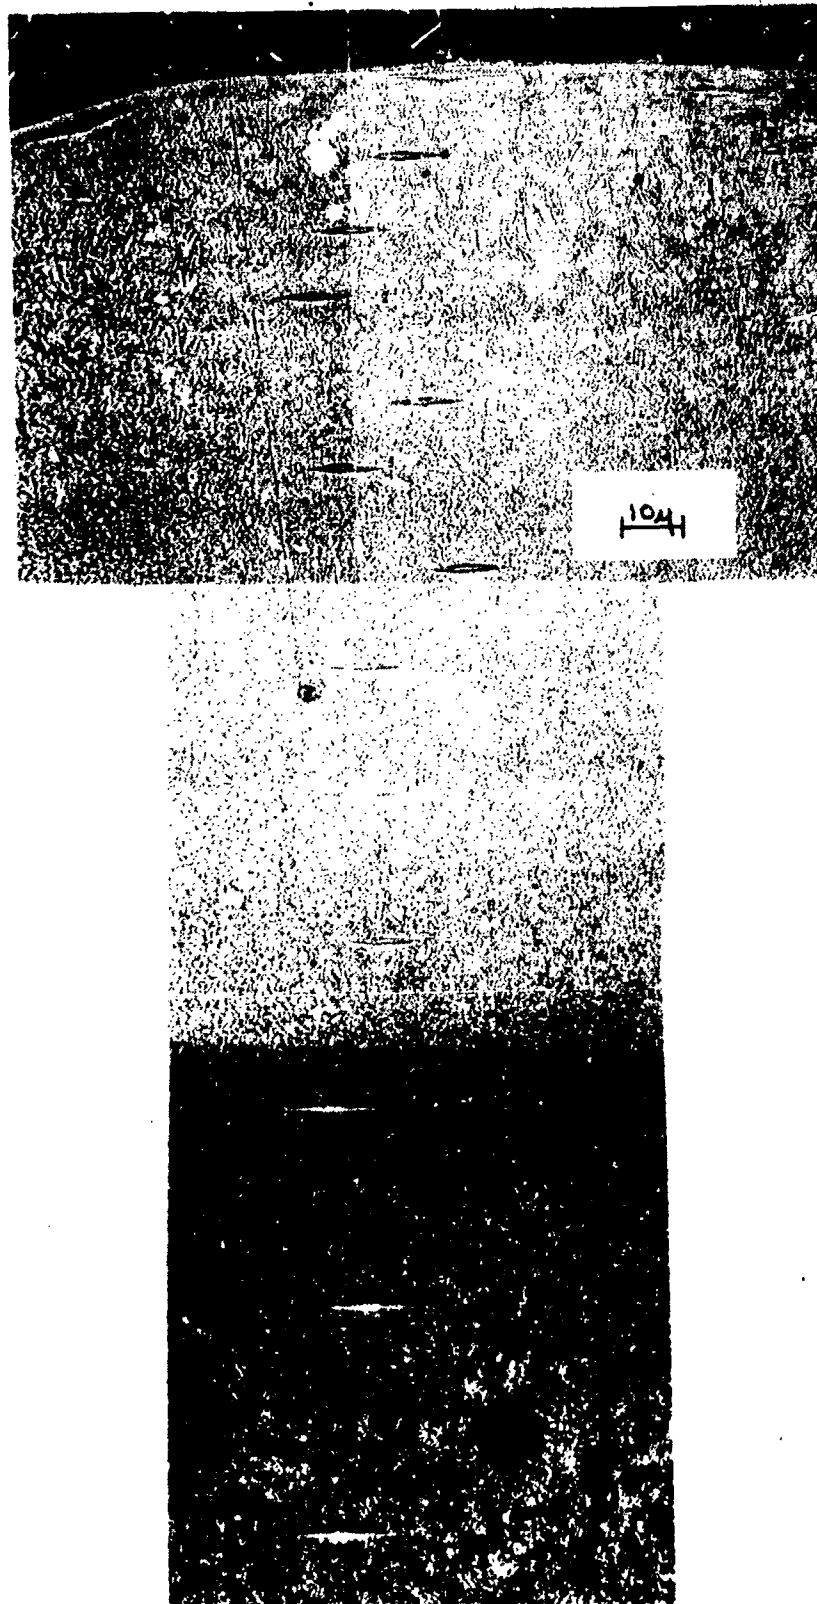
Figure 5b. Tube fired with Naco, 1590 rounds. Hardness variation across the thermally altered layer. 10g load, KHN indenter, etchant 2% Nital.
